QUAKERTOWN COMMUNITY SCHOOL DISTRICT

FEASIBILITY STUDY AND
DISTRICT MASTER PLANNING

ASSESSMENT PRESENTATION

January 26, 2016

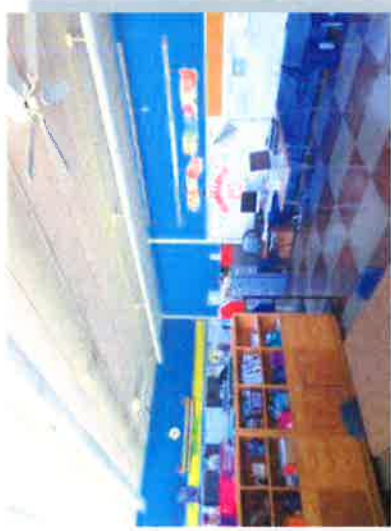
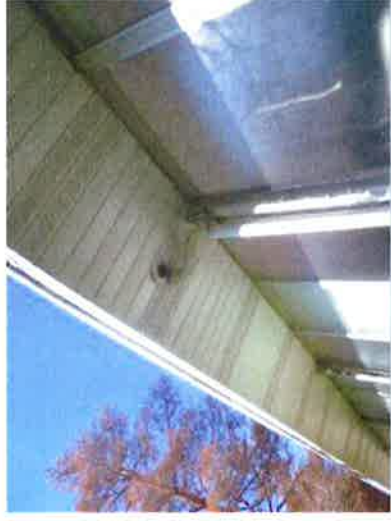
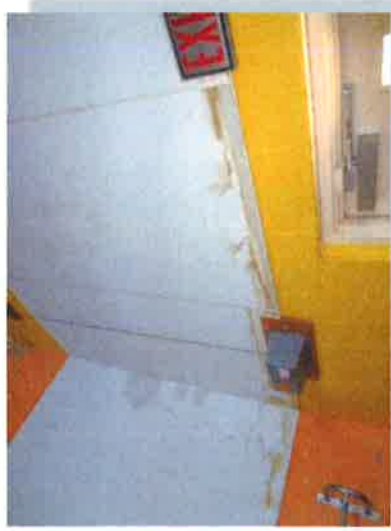
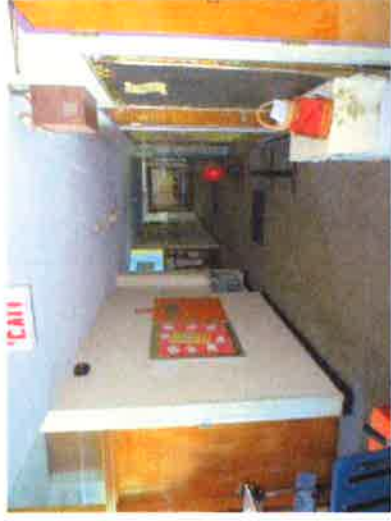
Typical Images

1. Code – ADA upgrades required. Misc Building Code upgrades required
2. Site – Bus-car separation, storm water, no public utilities, septic is failing, topography constraints
3. Roofing – Poor slope to drains, beyond warranty, replace in entirety
4. Windows – Single pane, metal frames, replace in entirety (energy efficiency)
5. Envelope – Reconstruct failing masonry
6. Finishes – Replace floors, ceilings, casework, repaint
7. Electrical – End of systems useful life. Replace in entirety
8. Technology – upgrade as required
9. HVAC – End of systems useful life. Replace in entirety
10. Plumbing/FP – End of systems useful life. Replace in entirety
11. Environmental – Abate in entirety, VAT, Pipe insulation & fittings, ceiling plaster

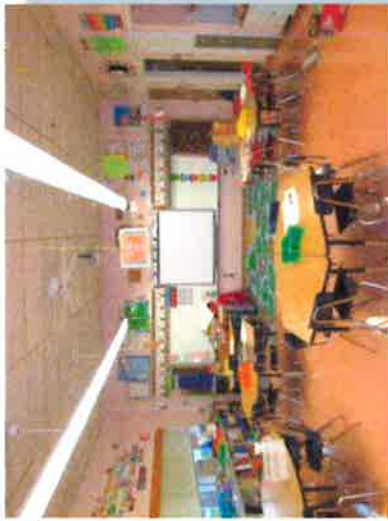
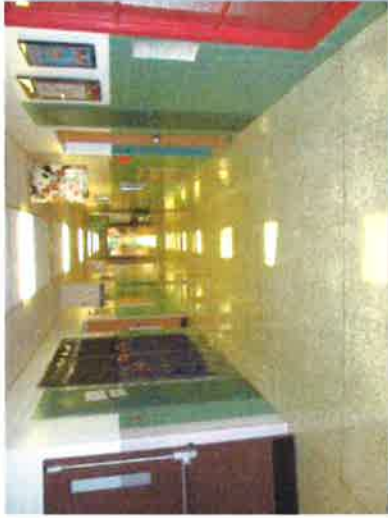
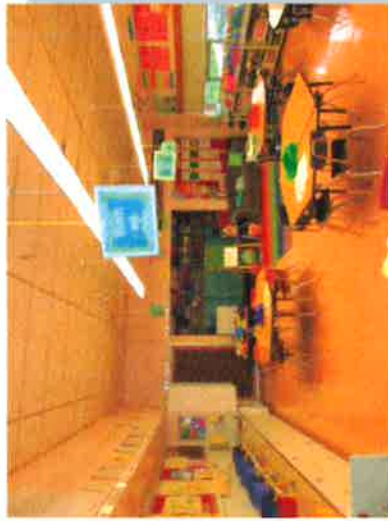
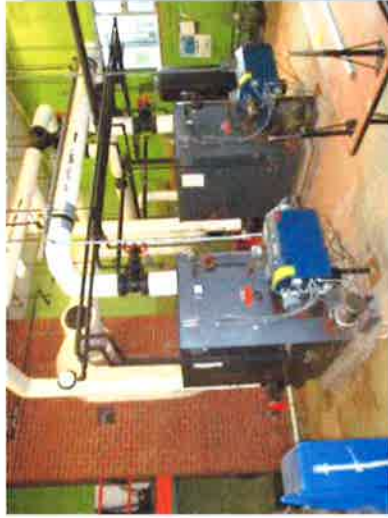
Typical Images

1. Code – ADA upgrades required. Misc Building Code upgrades required
2. Site – Bus-car separation, public utilities available, topography constraints
3. Roofing – Poor slope to drains, beyond warranty, replace in entirety
4. Windows – Single pane, metal frames, replace in entirety (energy efficiency)
5. Envelope – Soffit and fascia repairs and upgrades required
6. Finishes – Replace some floors, ceilings, casework, repaint
7. Electrical – Install occupancy sensors
8. Technology – upgrade as required
9. HVAC – Add AC, upgrade controls
10. Plumbing/FP – Fire protection upgrades and some fixture replacement
11. Environmental – Abate in entirety, VAT and mastic

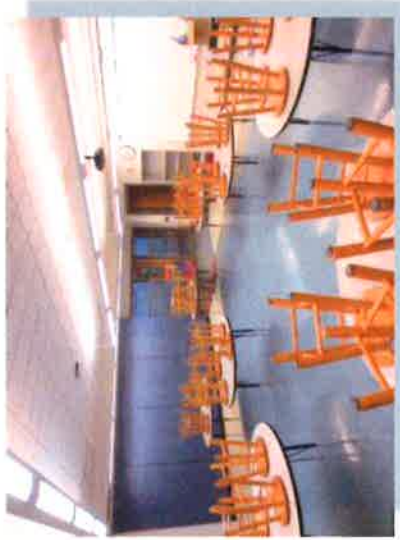
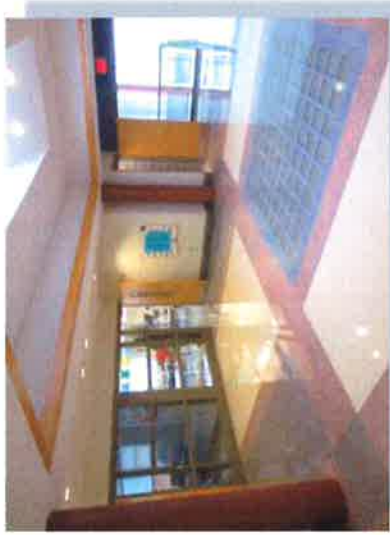
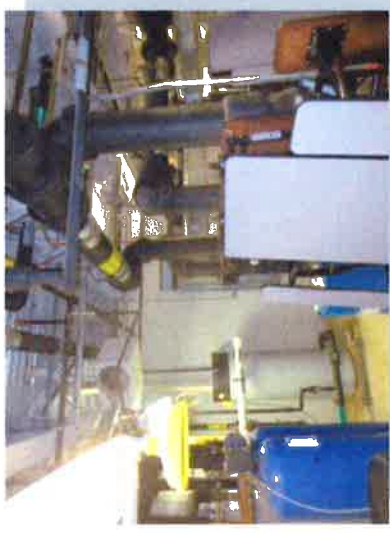
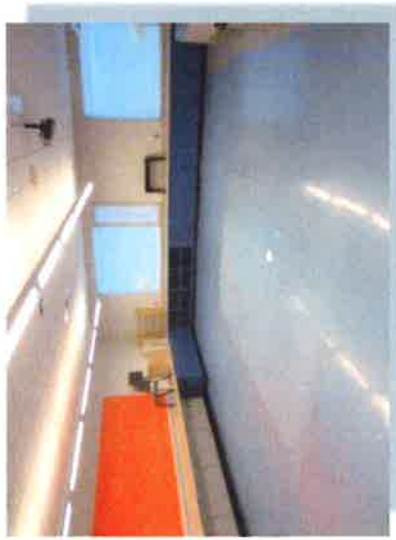
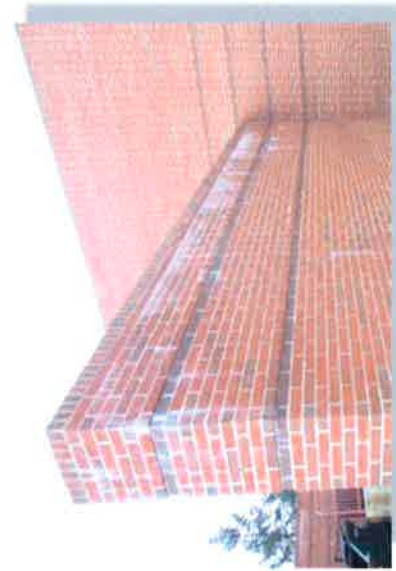
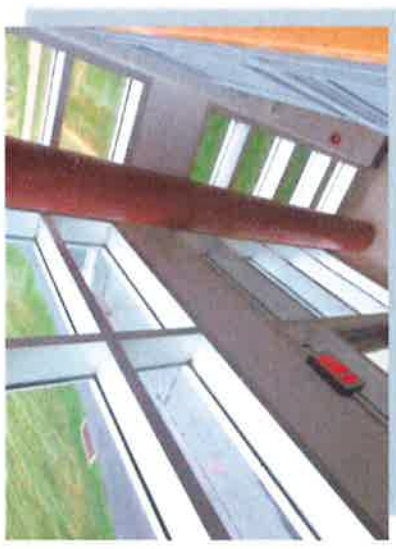
Typical Images

1. Code – Building is Code Compliant
2. Site – Site is in excellent condition
3. Roofing – 30 year warranty (2005 roof) – excellent condition
4. Windows – Energy efficient window systems provided
5. Envelope – Minor brick deterioration. Minor water infiltration @ rotunda
6. Finishes – Minor casework laminate issues
7. Electrical – Excellent condition
8. Technology – Excellent
9. HVAC – Minor issues – minor geothermal vault leak
10. Plumbing/FP – Excellent and compliant
11. Environmental – none

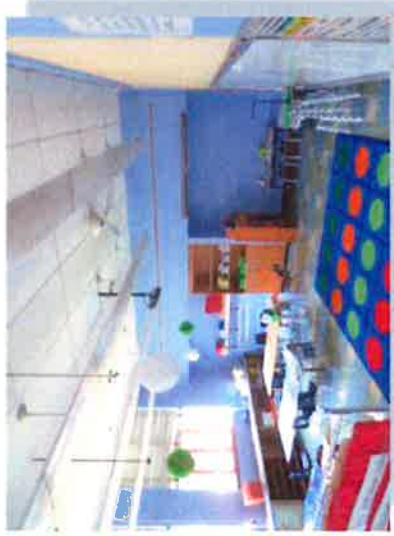
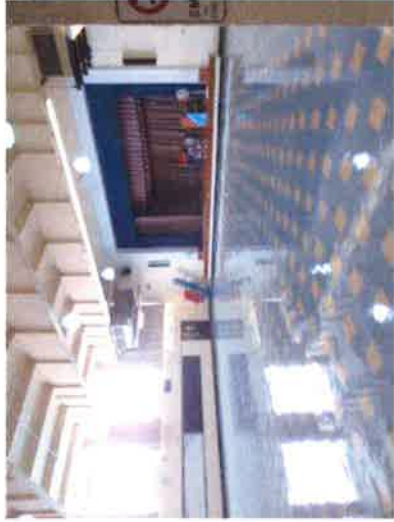
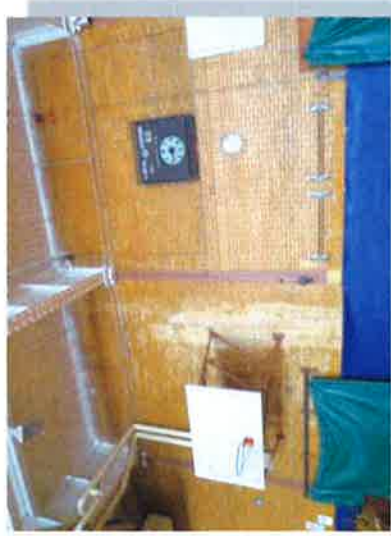
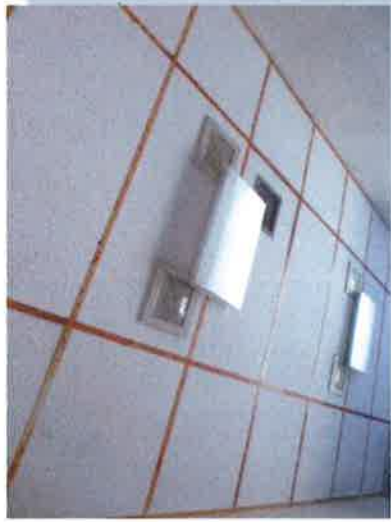
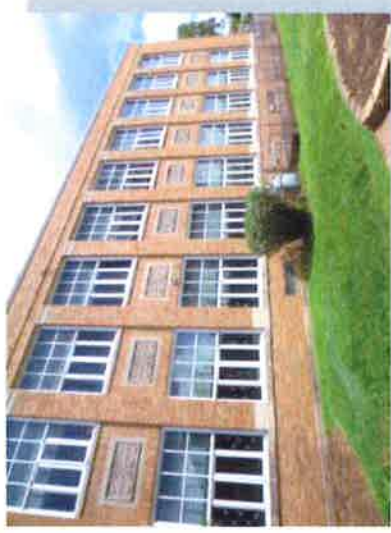
Typical Images

1. Code – ADA issues, Code issues, elevator required
2. Site – No separation of bus/ parent drop off, congestion, zoning issues
3. Roofing – Nearing end of warranty, Replace in entirety
4. Windows – Replace Kalwall @ gym/ some vented windows non-functional
5. Envelope – Misc. masonry repairs required throughout
6. Finishes – Floor, ceiling, finish, casework replacement required
7. Electrical – End of useful life. Lighting acceptable in locations
8. Technology – Requires upgrade
9. HVAC – End of useful life
10. Plumbing/FP – Requires upgrade and system implementation
11. Environmental – Abate in entirety

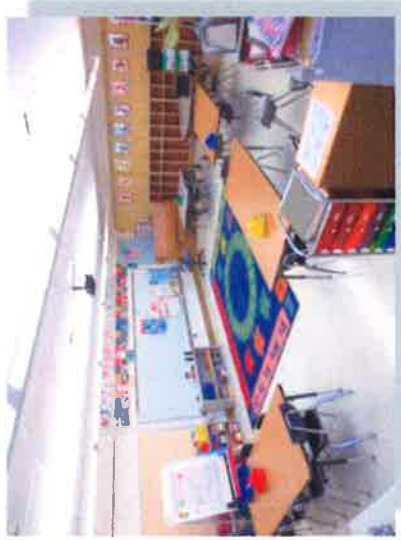
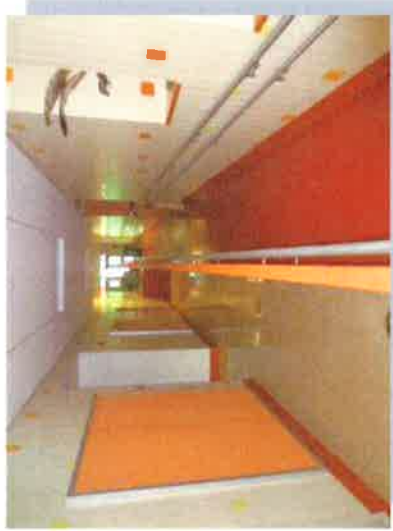
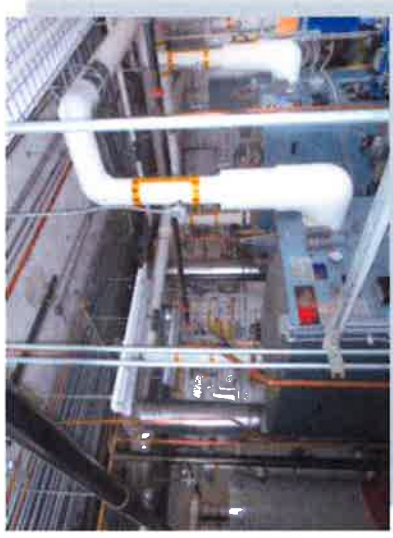
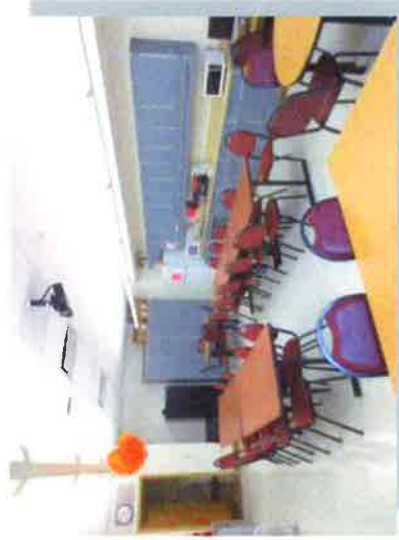
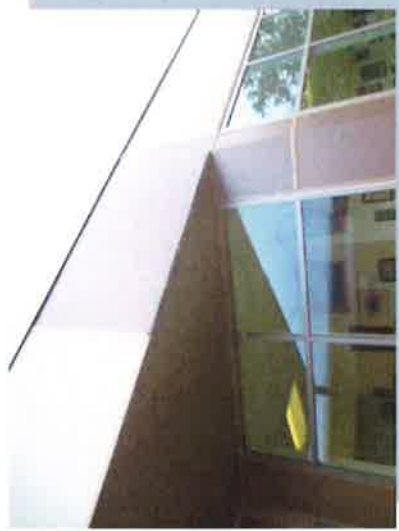
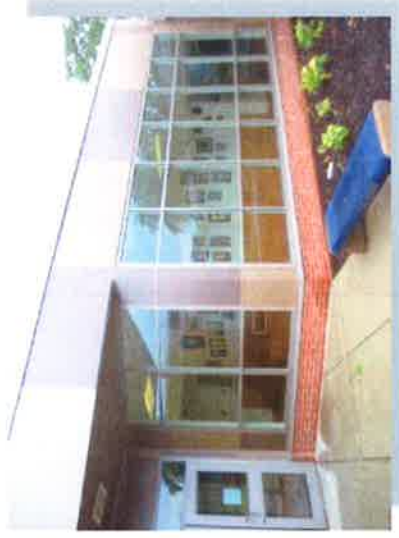
Typical Images

1. Code – Code compliant
2. Site – Issues of ponding water on site, parking shortcomings
3. Roofing – Good condition and warranty, some ponding
4. Windows – Excellent condition
5. Envelope – Minor metal panel system repair required/ Misc masonry repair
6. Finishes – Good condition
7. Electrical – Good condition
8. Technology – Good condition
9. HVAC – Good condition
10. Plumbing/FP – Good condition, fully sprinklered
11. Environmental – nothing required

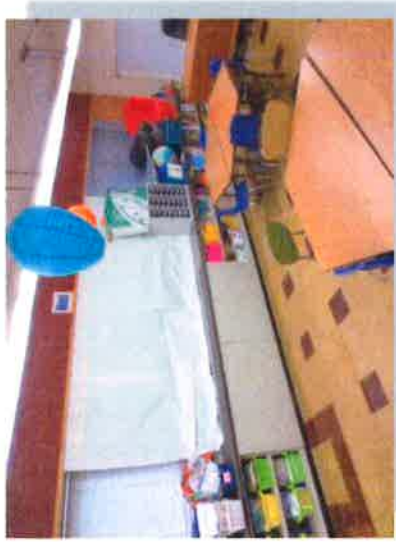
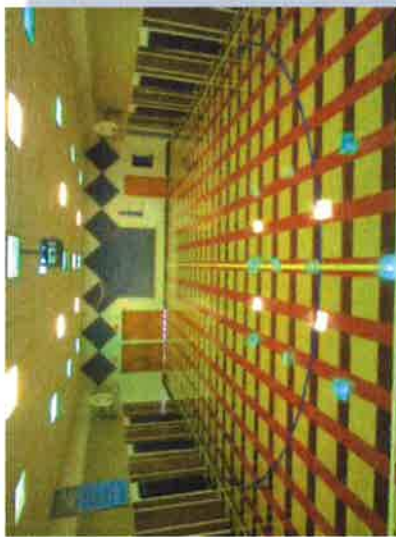
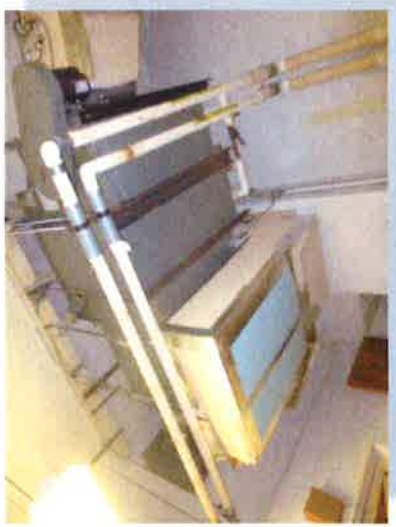
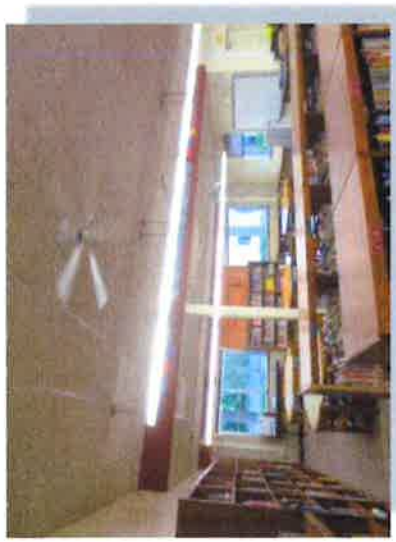
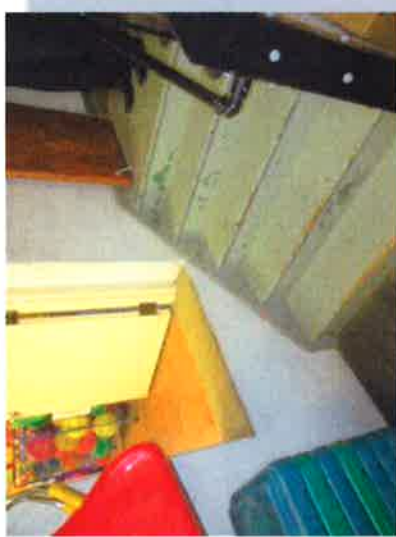
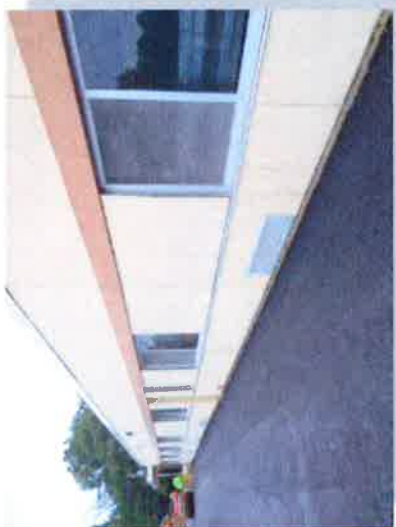
Typical Images

1. Code – ADA and building code upgrades required
2. Site – Difficult bus-car separation
3. Roofing – Out of warranty, misc repairs required short term, replace in entirety at some point
4. Windows – Replace in entirety
5. Envelope – EIFS repairs required throughout
6. Finishes – Replace floors, ceilings, finishes, casework throughout
7. Electrical – Replace lighting and controls
8. Technology – upgrade as required
9. HVAC – Add AC, upgrade controls, replace in entirety
10. Plumbing/FP – Fire protection and fixture replacement
11. Environmental – Abate in entirety, VAT and mastic

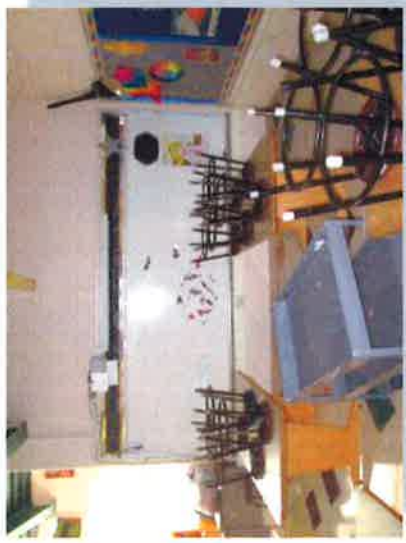
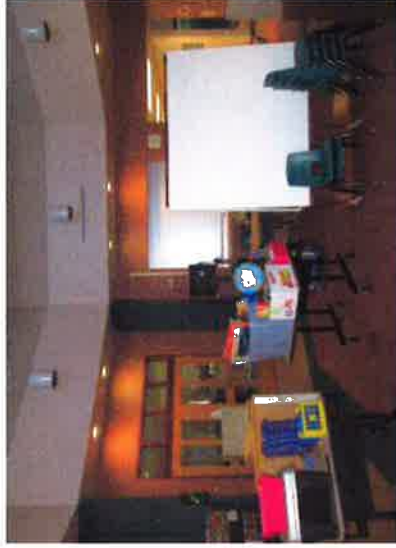
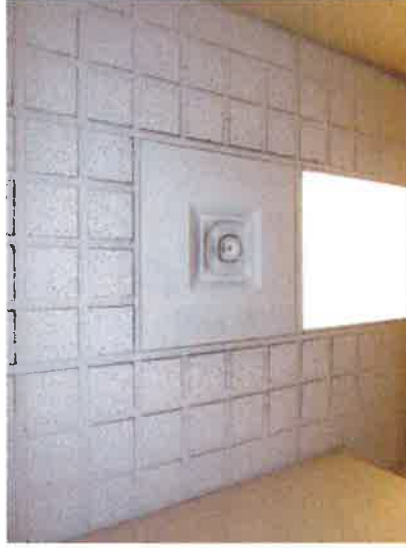
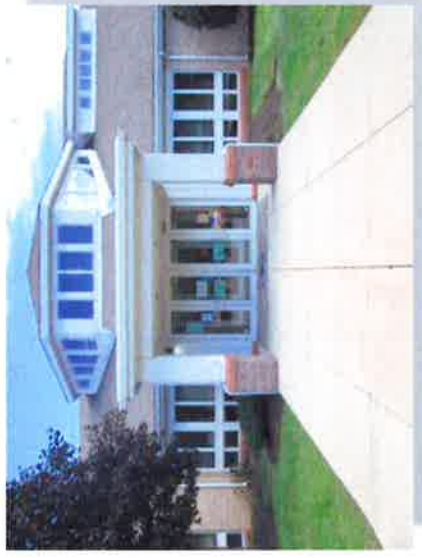
Typical Images

1. Code – ADA and building code upgrades required
2. Site – Good site
3. Roofing – Out of warranty, replace in entirety at some point
4. Windows – Good window system
5. Envelope – Minor masonry repointing required
6. Finishes – Future replacement of floor, ceiling, casework
7. Electrical – Systems and lighting in good condition
8. Technology – Good condition
9. HVAC – Control upgrades to tie systems into BMS
10. Plumbing/FP – Verify fire protection compliance
11. Environmental – No issues

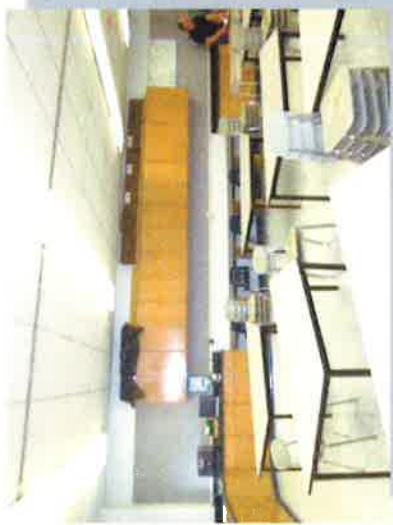
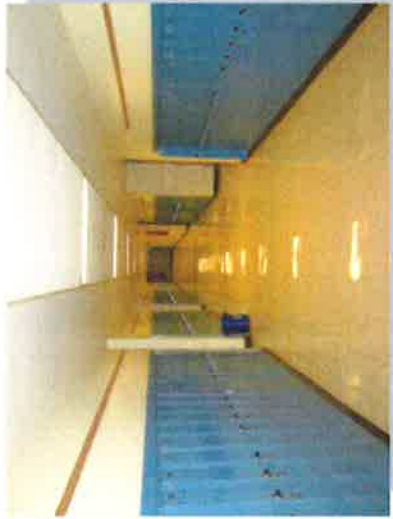
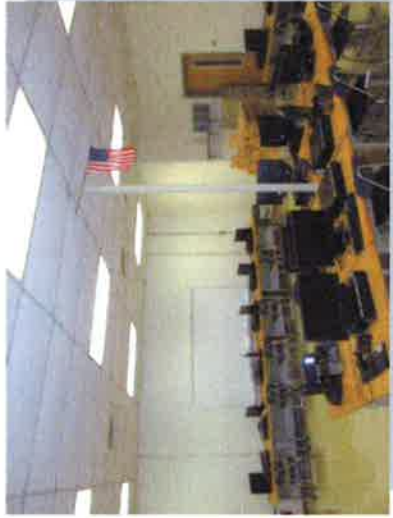
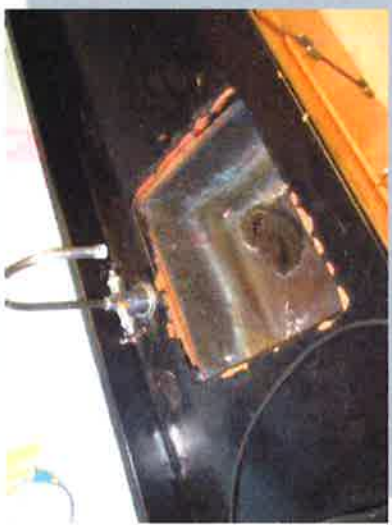
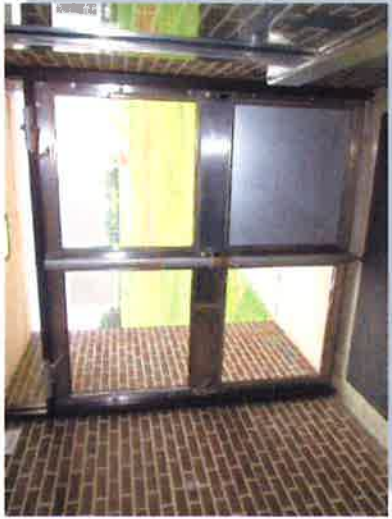
Typical Images

1. Code – ADA upgrades required. Misc Building Code upgrades required
2. Site – Storm water and other current code issues, no public water, gas, poor site lighting
3. Roofing – Replace in entirety
4. Windows – Recent window replacement
5. Envelope – Masonry repointing required, EIFS repairs, soffit replacement
6. Finishes – Replace floors, ceilings, casework, repaint
7. Electrical – Fair condition, Consider lighting replacement
8. Technology – Fair condition, upgrade as required
9. HVAC – Replace HVAC systems
10. Plumbing/FP – Sprinkler entire building
11. Environmental – Abate in entirety, VAT and mastic

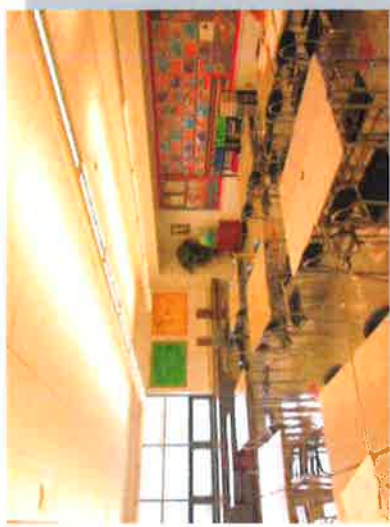
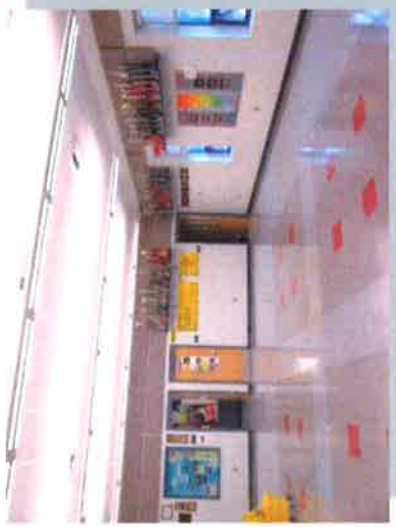
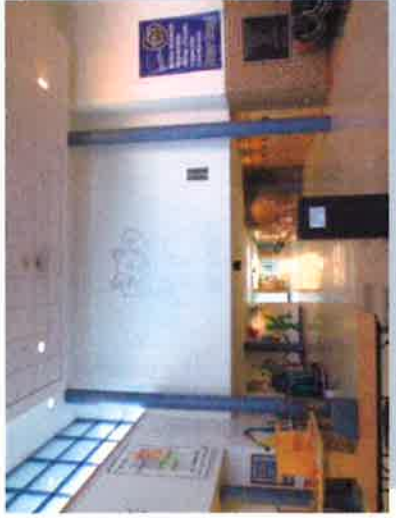
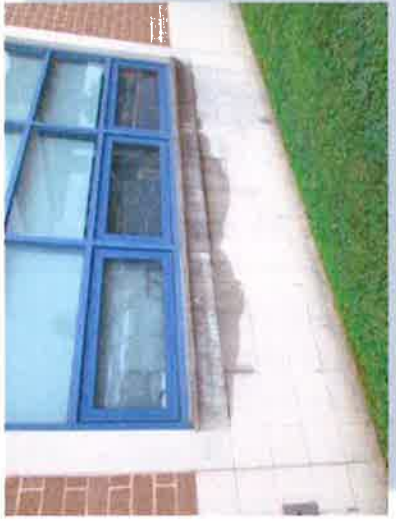
Typical Images

1. Code – Building is Code Compliant
2. Site – Site is in excellent condition, playing field discussions if Ronald Reagan Drive is continued
3. Roofing – Under warranty through 2034
4. Windows – Energy efficient window systems provided
5. Envelope – Minor masonry and water infiltration issues
6. Finishes – Excellent
7. Electrical – Excellent Technology – Excellent
8. HVAC – Upgrade BMS systems
9. Plumbing/FP – Excellent and compliant
10. Environmental – none

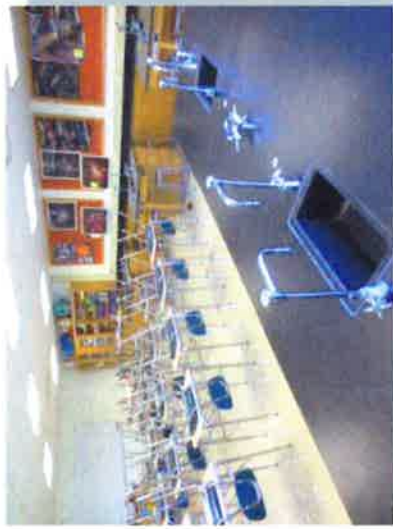
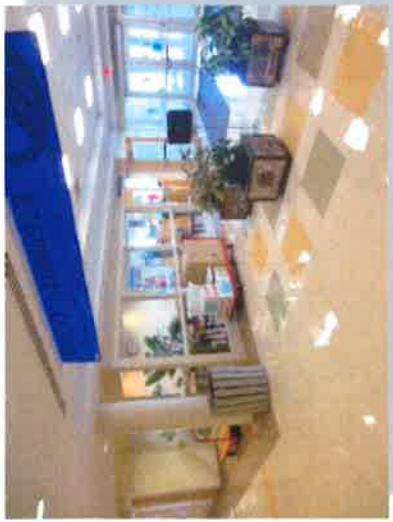
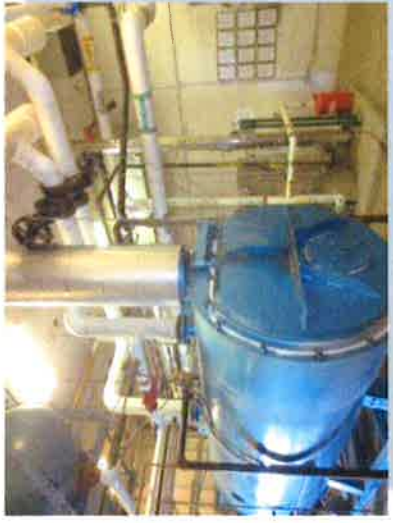
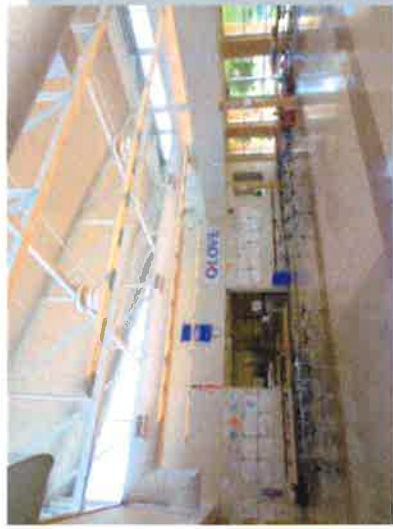
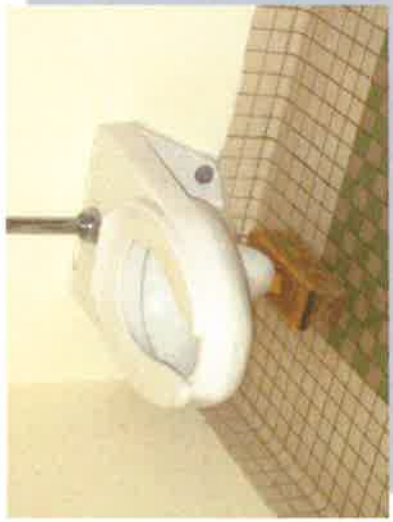
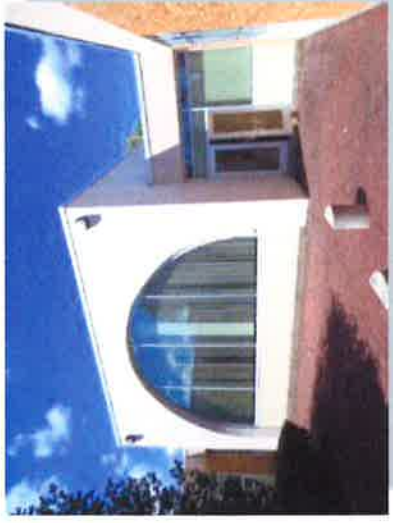
Typical Images

1. Code – Building is Code Compliant
2. Site – 9th Street traffic issues, concrete walk connector to high school
3. Roofing – Warranty nearing expiration, replace in entirety
4. Windows – Water infiltration, flashing detail issues
5. Envelope – Masonry water infiltration, misc re-pointing, EIFS repairs
6. Finishes – Some floor, ceiling casework upgrades required
7. Electrical – Good condition
8. Technology – Good condition
9. HVAC – Upgrade BMS systems
10. Plumbing/FP – Compliant
11. Environmental – none

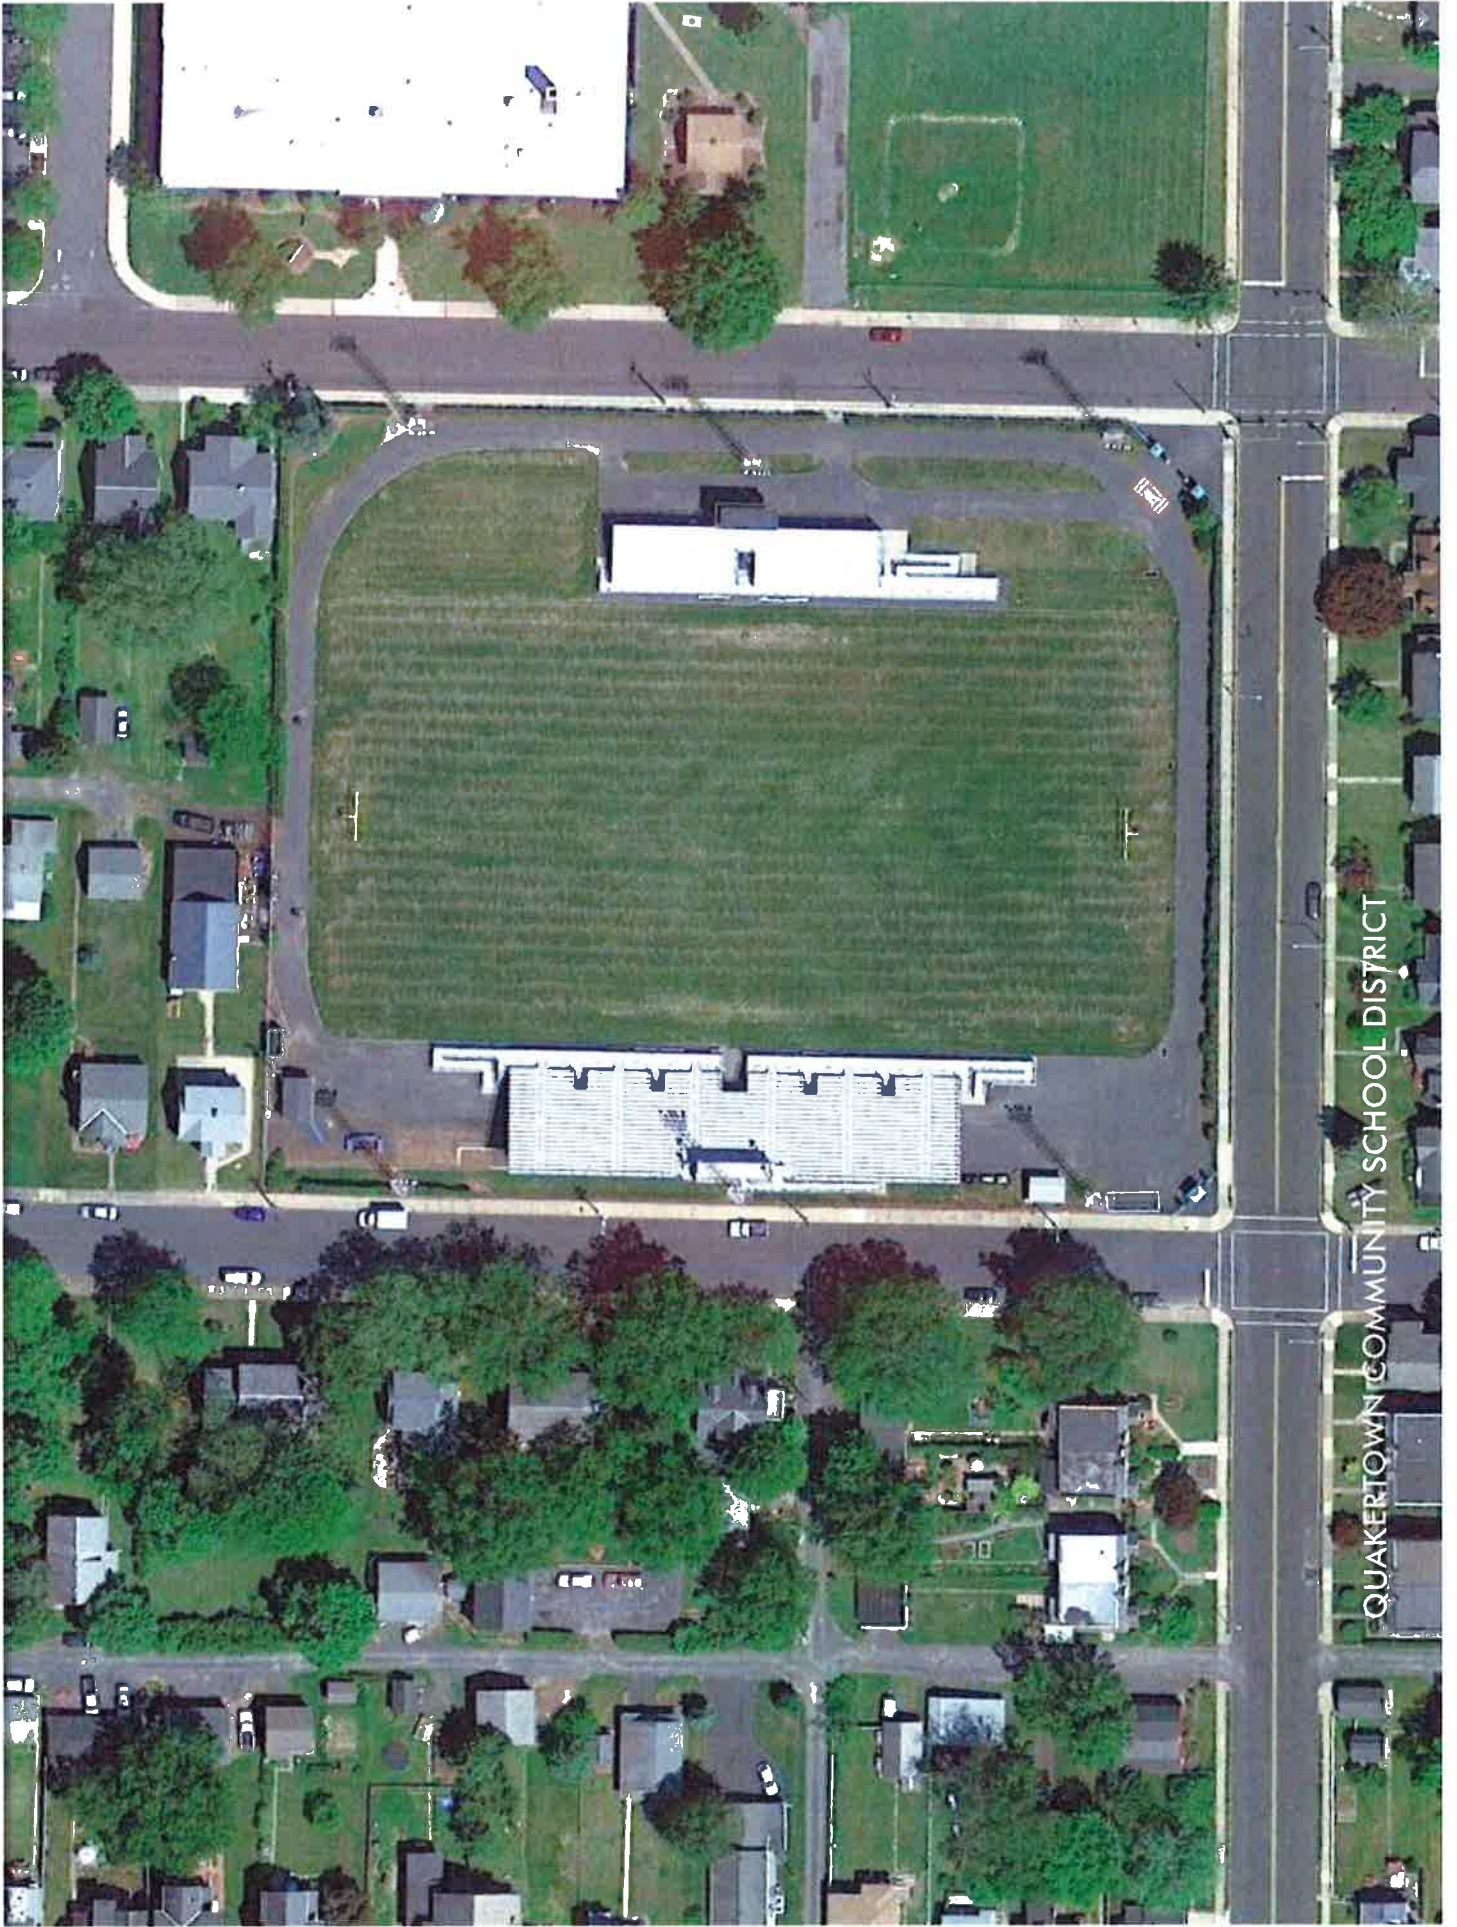
Facility Assessment

1. Code –Code Compliant
2. Site – Turf field considerations
3. Roofing –
4. Windows –
5. Envelope – Misc Masonry repairs, fastener connection points
6. Finishes – Strip and repair heavy traffic sealer at visitor side bleachers
7. Electrical – Lighting control structure, remove and reconstruct, add fire alarm
8. Technology –
9. HVAC –
10. Plumbing/FP – Provide dry-type sprinkler
11. Environmental – none

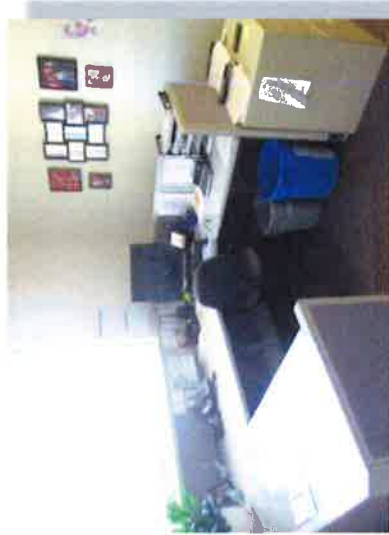
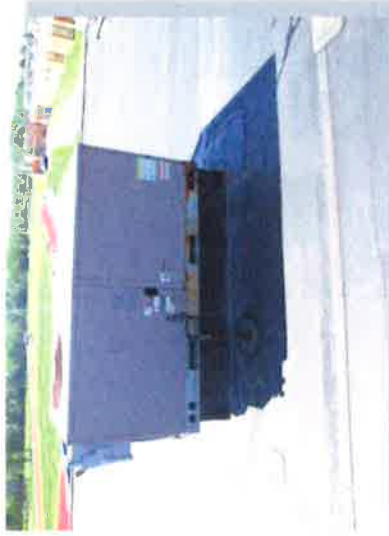
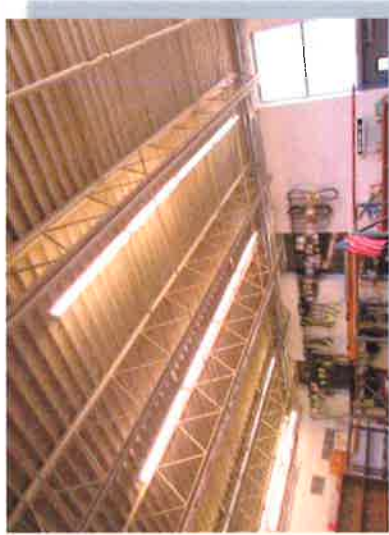
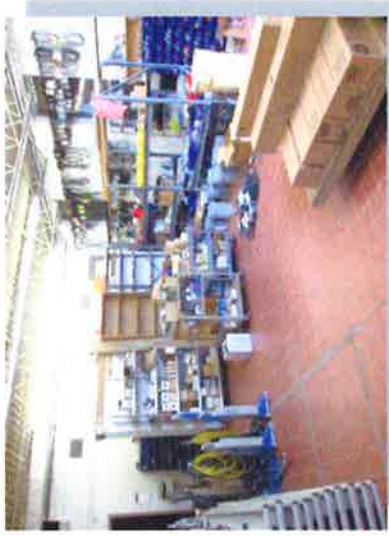
Typical Images

1. Code – Non-ADA compliant toilet room and fixtures, non-accessible building entry
2. Site –
3. Roofing – Replace in entirety
4. Windows –
5. Envelope – Recently repainted
6. Finishes – Upgrade floors/ ceilings
7. Electrical – Add fire alarm
8. Technology –
9. HVAC – Replace RTU
10. Plumbing/FP – Provide sprinkler
11. Environmental – Abate in entirety, transite panels/ ACM insulation

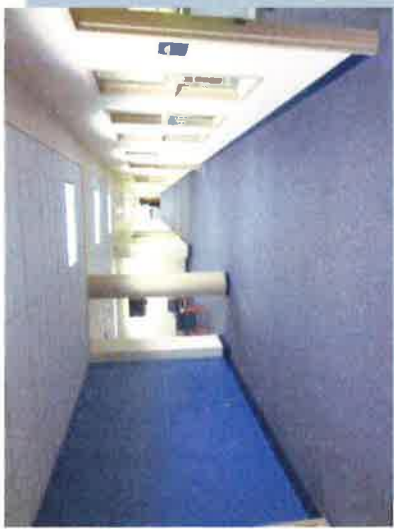
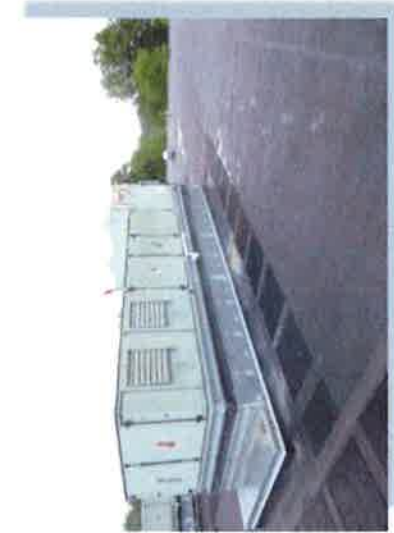
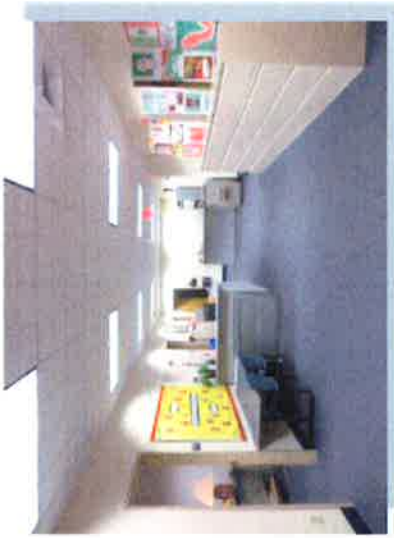
Typical images

1. Code – Building is code-compliant
2. Site – Replace damaged curb, sidewalk
3. Roofing – Metal coping repairs
4. Windows – Good condition
5. Envelope – Lacking building insulation, leaking scupper boxes
6. Finishes – Good condition
7. Electrical – Good condition
8. Technology – Good condition
9. HVAC – Building fails to maintain temp below 25 degrees and above 90 degrees
10. Plumbing/FP – Fully sprinklered
11. Environmental – None
